Swiss Safety Center AG
Materials Technology
Richtistrasse 15
CH-8304 Wallisellen

No.: 17016972

Document type: Investigation report
Title: Failure analysis of a compressed air container
Items tested: An aluminium compressed air container
Material: AW-7075
Total pages: 13 (incl. cover sheet)
Order received: 27/06/2018 by email
Goods received: 25/06/2018
Customer: Morini Competition Arm SA / CH-6930

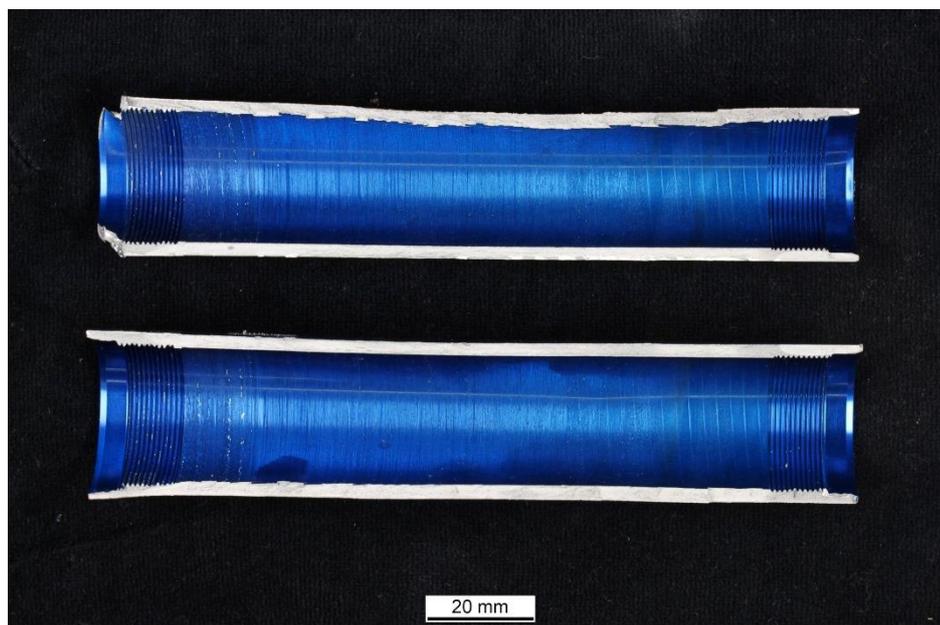
The item examined was a ruptured compressed air cylinder (Photos 1 to 2, Annex 1.1). According to information supplied by the customer, the material used was a high-tensile type 7075 aluminium alloy in heat treatment condition T6. The customer requested that a failure analysis examination be carried out to determine the cause of the rupture. This draft report presents the current status of our examinations as at 13 July 2018.

Photo 1: The broken specimen as delivered.

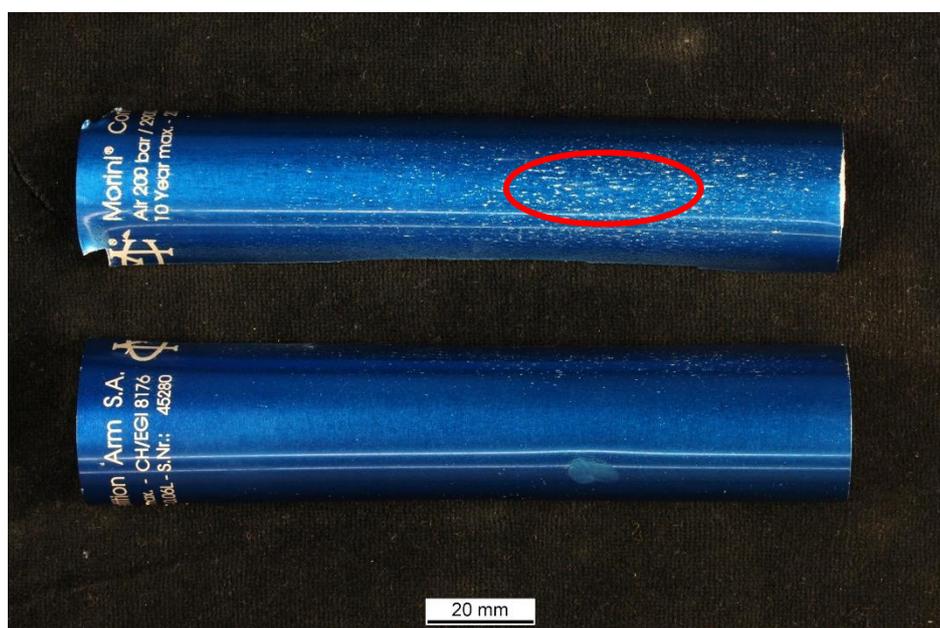
A conspicuous feature of the cylinder's surface was the presence of numerous corrosion scars. The area around the rupture on the container displayed a partly fissured fracture structure but with minimal deformation. There was a distinctive semi-elliptical structure which showed up as a bright shiny area. Consequently, it was possible to localise the fracture origination point to the outer side of the cylinder. The rest of the fracture area was of a uniformly grey colour (Photos 3 to 4, Annex 1.2).

Photo 2: The broken specimen as delivered. The areas of corrosion attack are conspicuous (circle).

Based on the condition of the surface, it can be stated that the outer side of the component had been exposed to a corrosive atmosphere containing chloride. The condition of the surface together with the numerous secondary cracks are indications of inappropriate handling and/or storage conditions. The cylinders had, however, been given a decoratively anodised coating, providing them with protection against the usual slight amounts of corrosion. But the cylinders were not designed to withstand the aggressive conditions which appeared to pertain here. Contact with an aggressive medium, which is essential for stress corrosion cracking to occur, can be prevented by appropriate handling and storage.

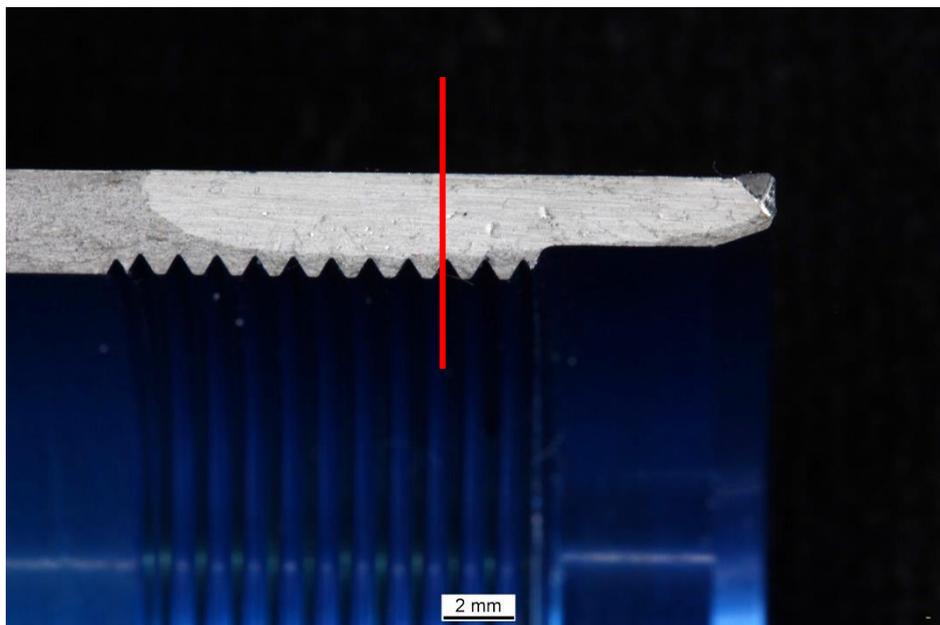
Photo 3: Close-up of the fracture area showing the bright semi-elliptical fracture origination zone. The section plane for the metallographic examination is indicated by the red line.

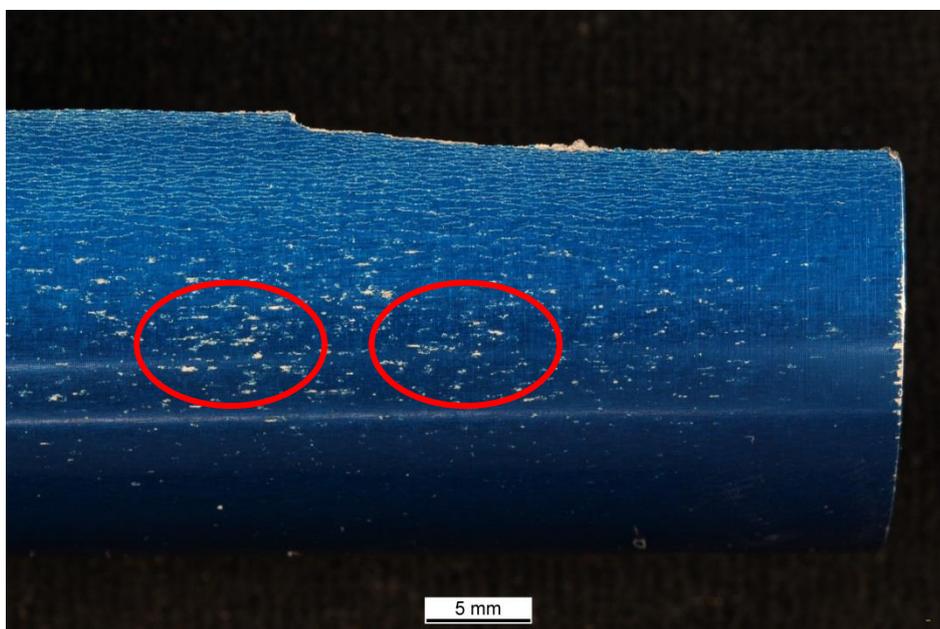
Photo 4: Side view of the cylinder with areas of corrosion attack (circles).

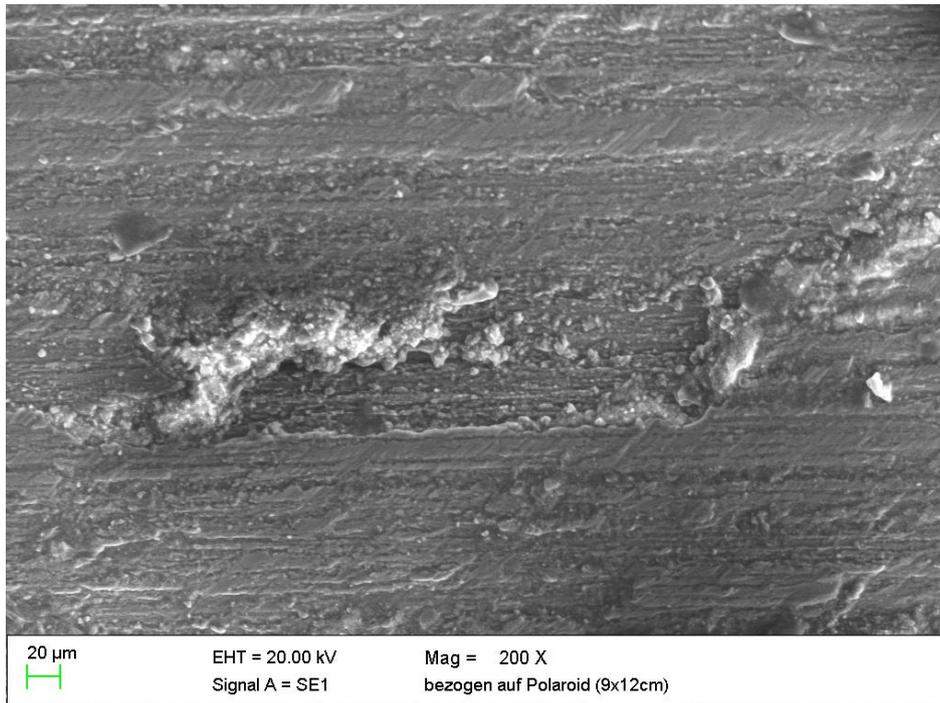
Under the scanning electron microscope, a smooth intergranular structure coated with corrosion products could be seen in the area of primary cracking. Secondary cracks could be detected on the surface in the fracture origination area. The final forced fracture exhibited the characteristics of a microductile forced rupture (Photos 5 to 9, Annexes 1.3 to 1.5).

Photo 5: SEM image of the broken specimen: fracture origination point. Fracture surface partly coated with corrosion products.

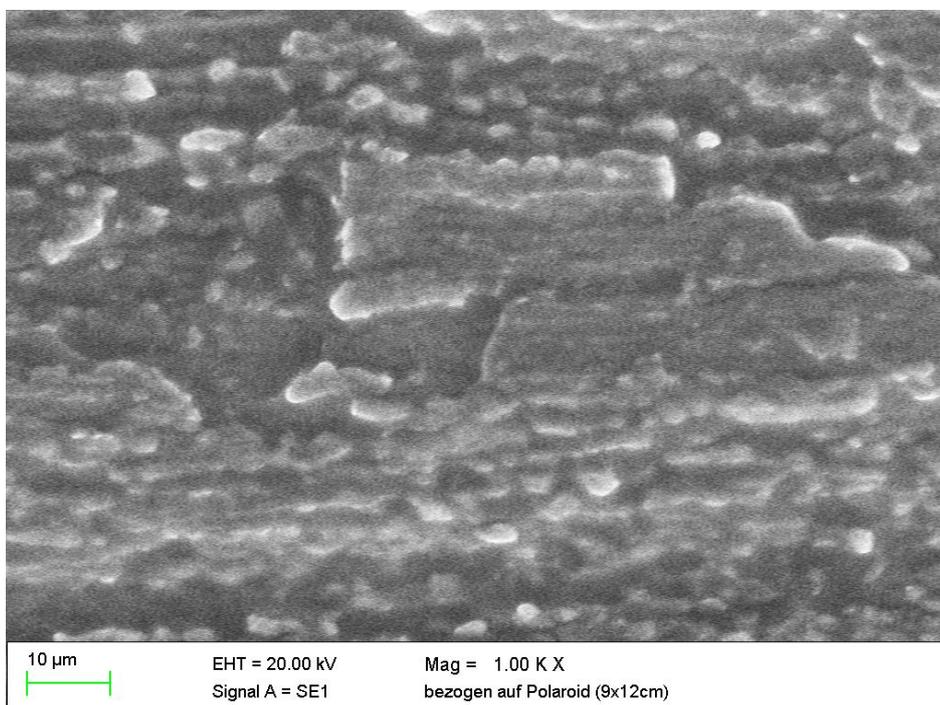
Photo 6: SEM image of the broken specimen: intergranular structure coated with corrosion products.

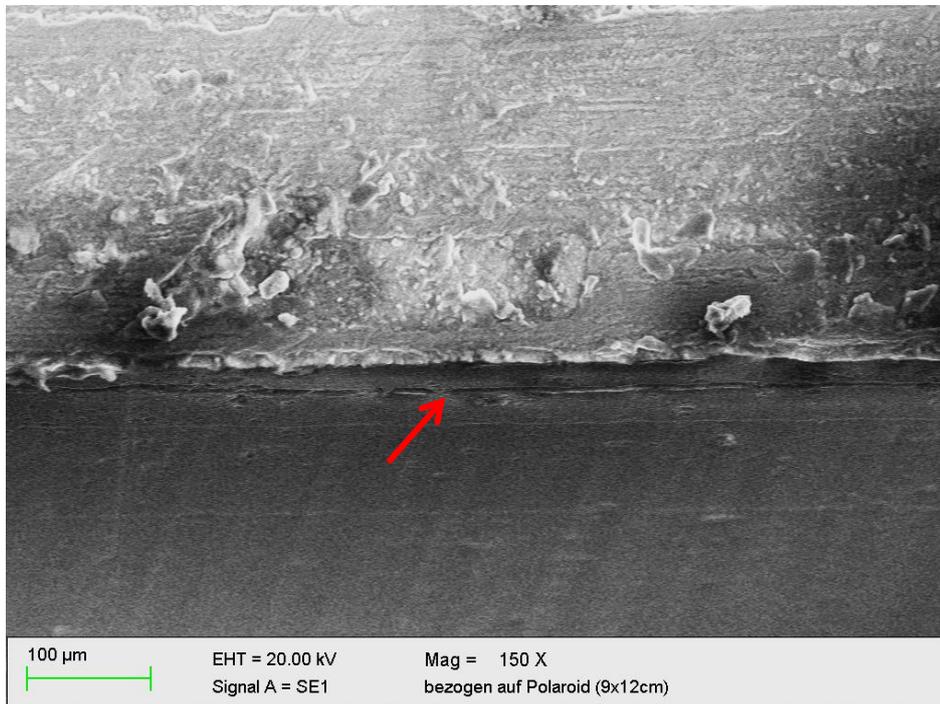
Photo 7: SEM image of the broken specimen: secondary crack (arrow) below the fracture origination point.

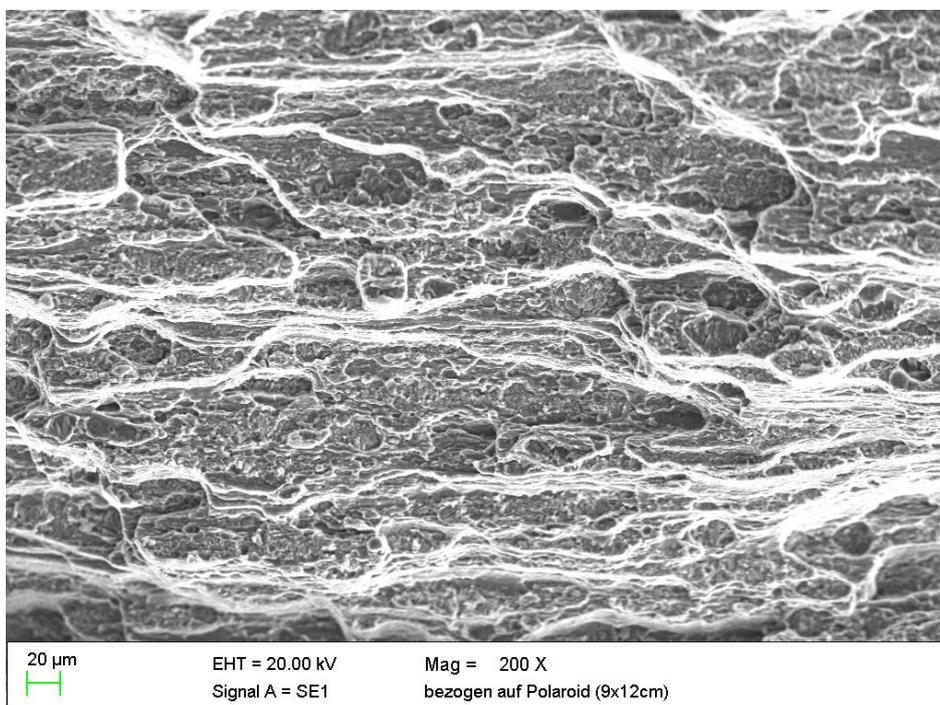
Photo 8: SEM image of the broken specimen: Final forced fracture; microductile fracture with dimples.

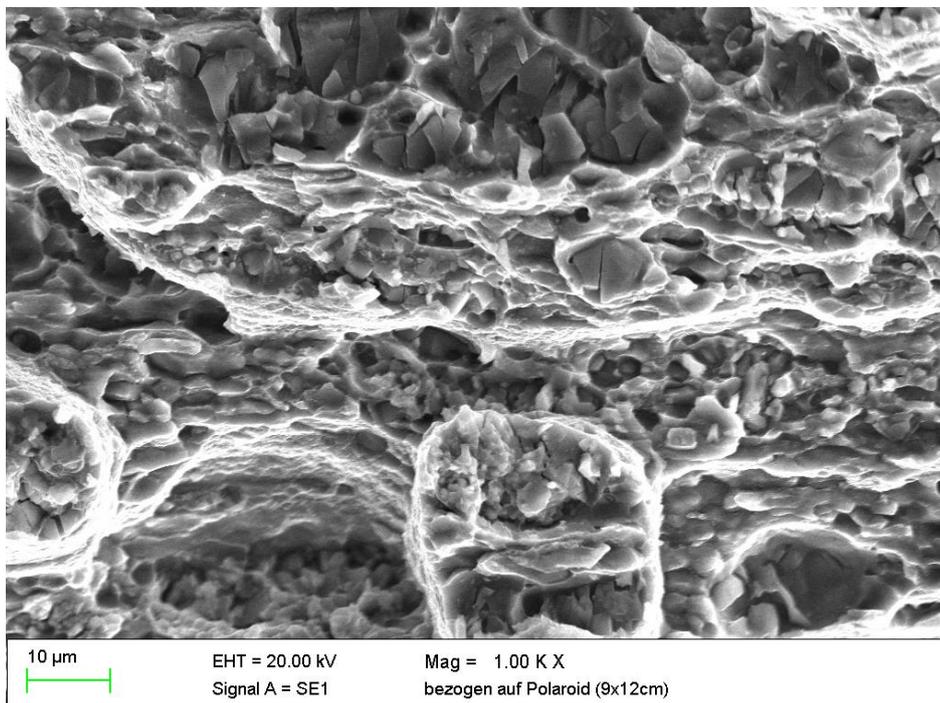
Photo 9: SEM image of the broken specimen: Final forced fracture; microductile fracture with dimples.

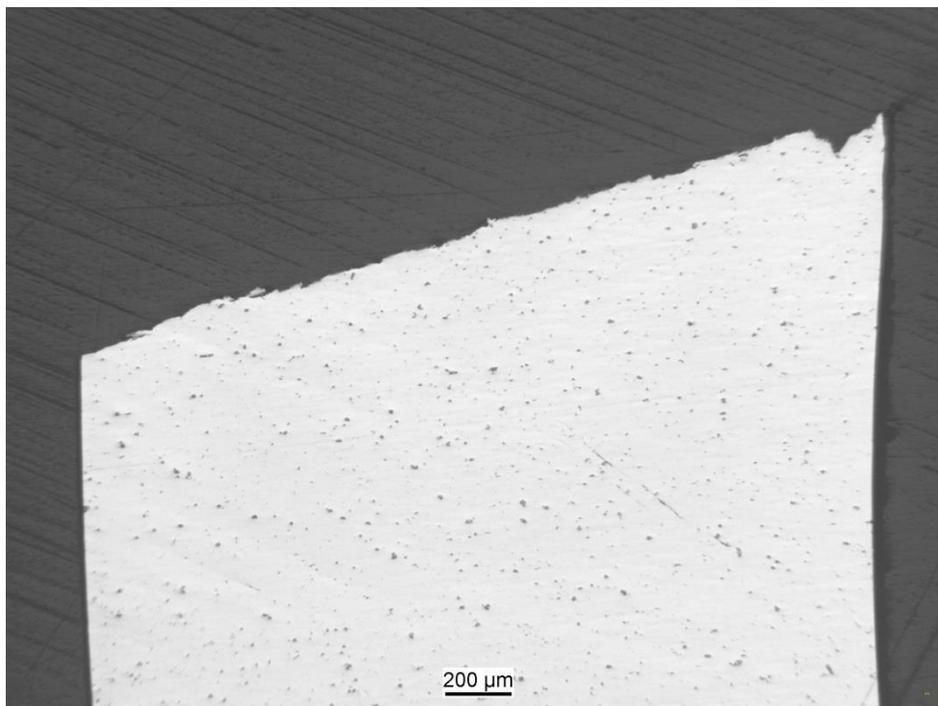
Photo 10: The broken specimen; polished microsection, side view of the fracture surface.

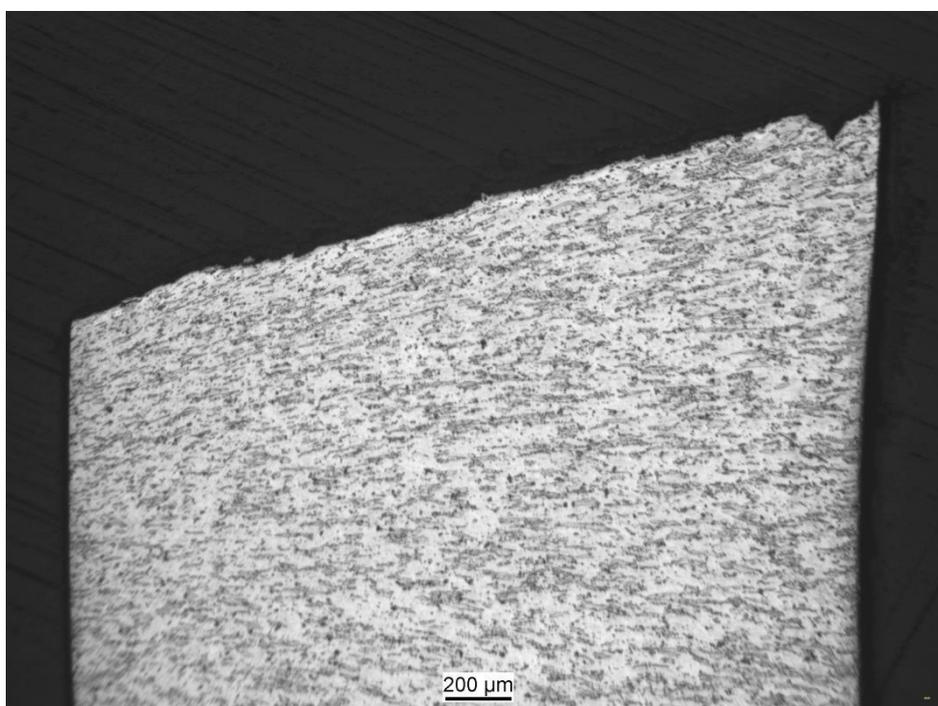
Branched crack systems emanating from the corrosion scars could be seen in the polished microsection. The etched microstructure displayed a compressed microstructure with intermetallic phases. The cracks very largely followed an intergranular path (Photos 10 to 13, Annexes 1.6 and 1.7).

Photo 11: The broken specimen; etched microsection, side view of the fracture surface. A compressed microstructure can be seen.

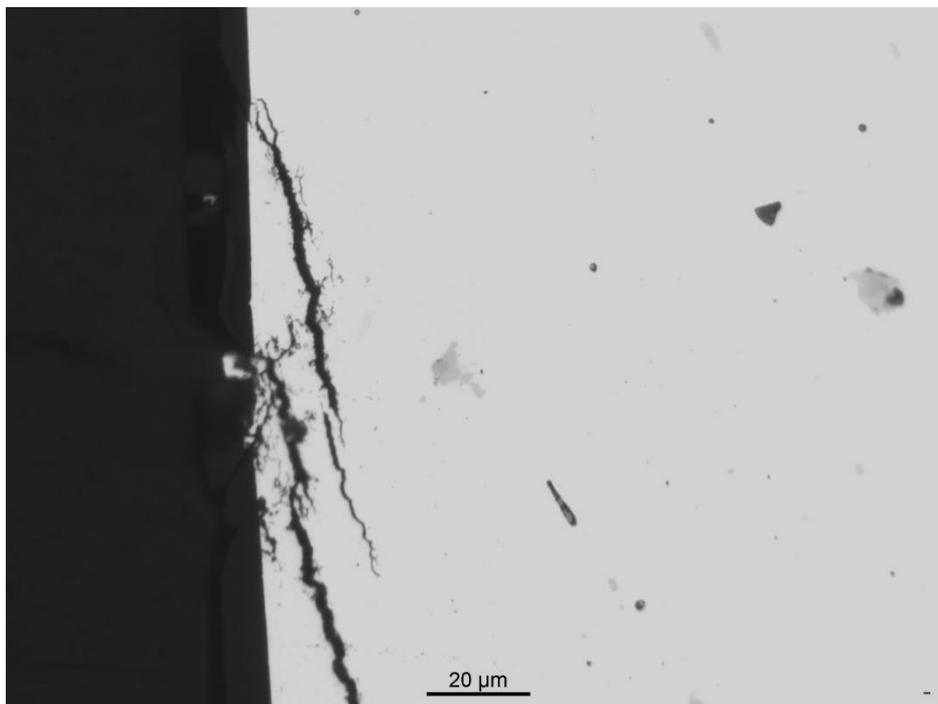
Photo 12: The broken specimen; polished microsection, illustrating a branched secondary crack emanating from a corrosion scar.

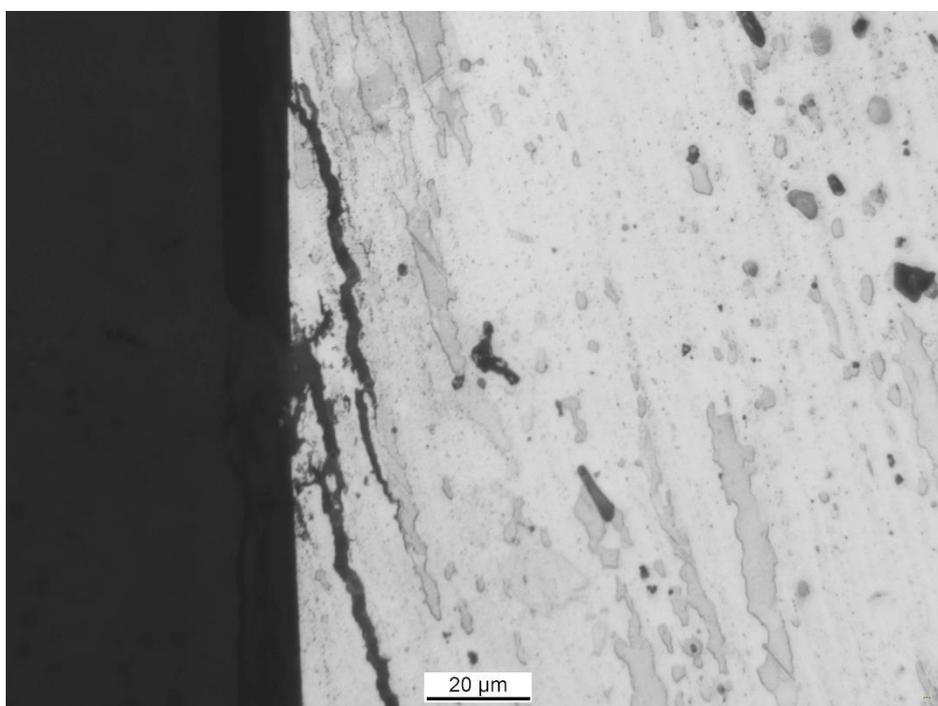
Photo 13: The broken specimen; etched microsection; intergranular crack pattern.

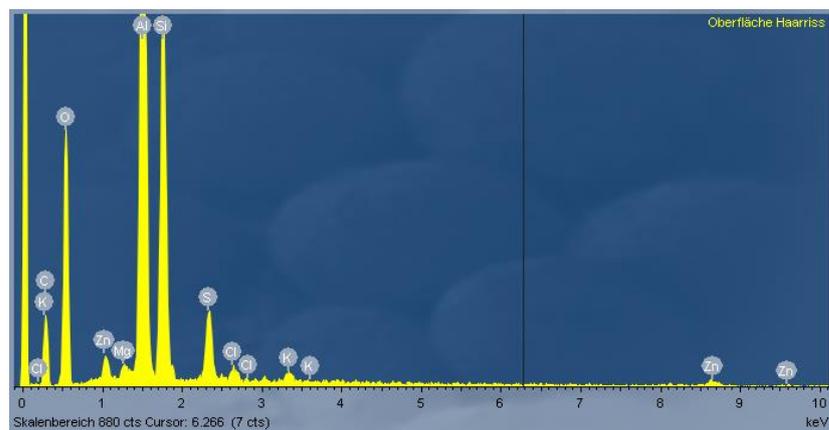
Energy dispersive X-ray identified chlorine in the corrosion products as the corrosion-inducing element (Spectrum 1, Annex 2.1).

Spectrum 1: Chloride as the corrosive substance on the surface of the aluminium cylinder.
