Hammerli 480K Repair Notes

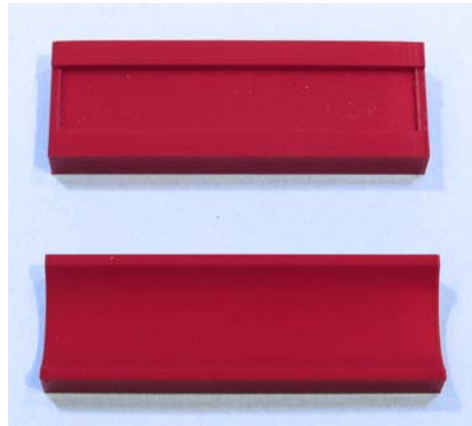
The replaceable vise jaws stick out a bit from the body of the vise, and the plastic jaws are printed with a pocket in the back that snaps onto the metal jaws.

I 3D printed vise jaws for my 4" Starrett bench vice, and made the inside radius 1.4 mm larger than the cylinder to allow using a sheet of silicone rubber as a pad/gripping aid. The rubber is <https://www.mcmaster.com/5773T22/>.

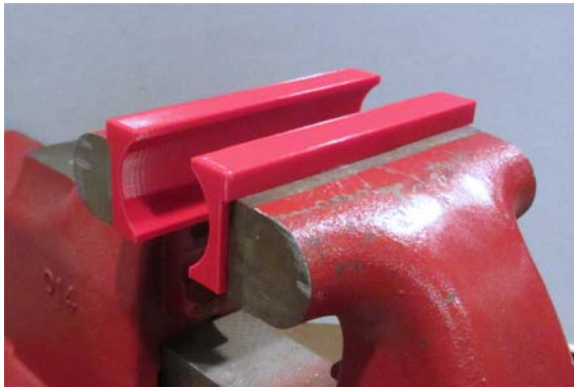
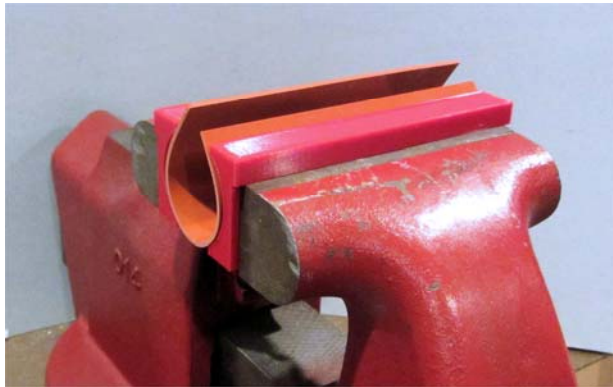
The plastic jaws are installed, and the rubber sheet is slipped in place:

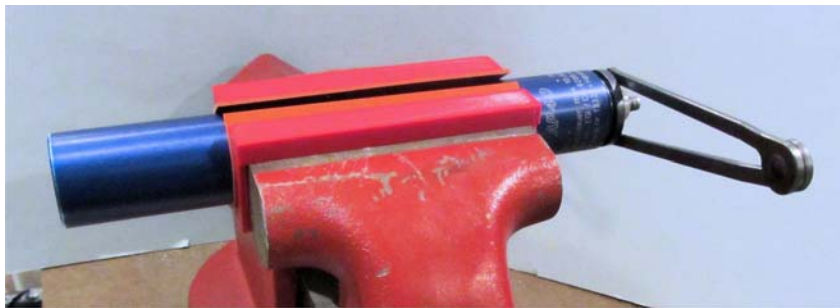
Insert the cylinder, tighten the vise good & snug, install the spanner and heave...

The valve end came loose, and I'm ready to repair or swap as needed.
